**Flood Control Project Maintenance
Levee Inspections**
LMA District Cover Sheet
Spring 2016 Levee Inspection Results

Reclamation District No. 2064 River Junction

Spring 2016 Levee Inspection Results

Levee Inspection Report By Mile - Spring 2016

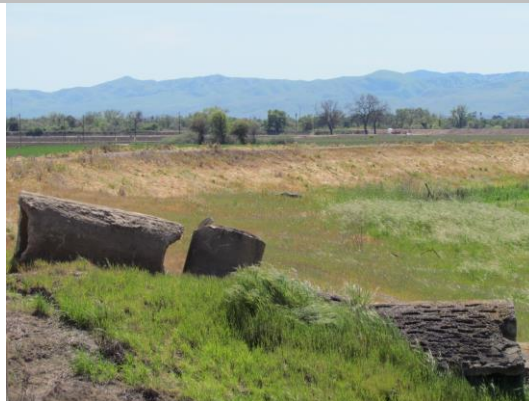
Photo 1 of 1 : SP_2016_RD2064_313_19_20160328_00038.jpg

LM Start	0.07	Rating **	A	Issue No.	19
LM End	5.54	Issue Type +	Ma	Location *	WS
Category	Earthen Levee			GPS Latitude/Longitude	
				Start	End
Item	Vegetation			37.709655 °	37.667376 °
				-121.267533 °	-121.241042 °
DWR ID	DWR_RD2064_01_s_2016_19				
Comment Code					
V1 : Control annual grass and weeds on the levee slopes and easements.					
Inspector Comment					
The waterside slope has been sprayed.

Looking downstream from levee mile 0.07 unit 1 RD 2064 landside slope.

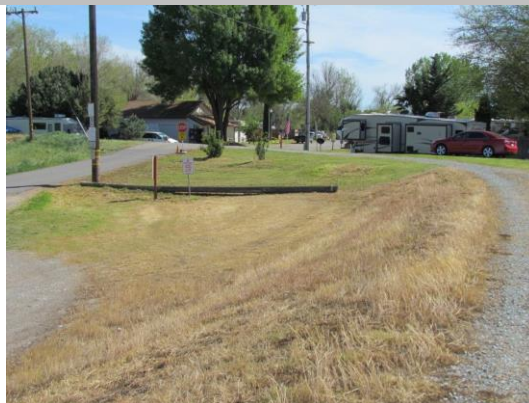
Photo 1 of 1 : SP_2016_RD2064_314_15_20160329_00028.jpg

LM Start	0.01	Rating **	A	Issue No.	15
LM End	4.20	Issue Type +	Ma	Location *	LS
Category	Earthen Levee			GPS Latitude/Longitude	
				Start	End
Item	Vegetation			37.666988 °	37.695455 °
				-121.240827 °	-121.206305 °
DWR ID	DWR_RD2064_02_s_2016_15				
Comment Code					
V1 : Control annual grass and weeds on the levee slopes and easements.					
Inspector Comment					
The slopes and shoulder has been sprayed.

Looking downstream from levee mile 0.01 Unit 2 RD 2064 landside slope.
